Inspection Report

33 Wild Raspberry Lane Cary, NC

Volpe Home Inspections

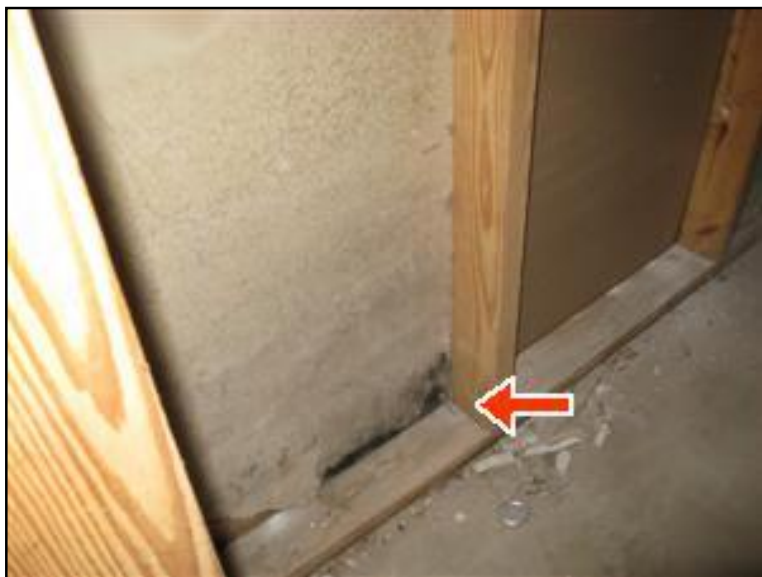
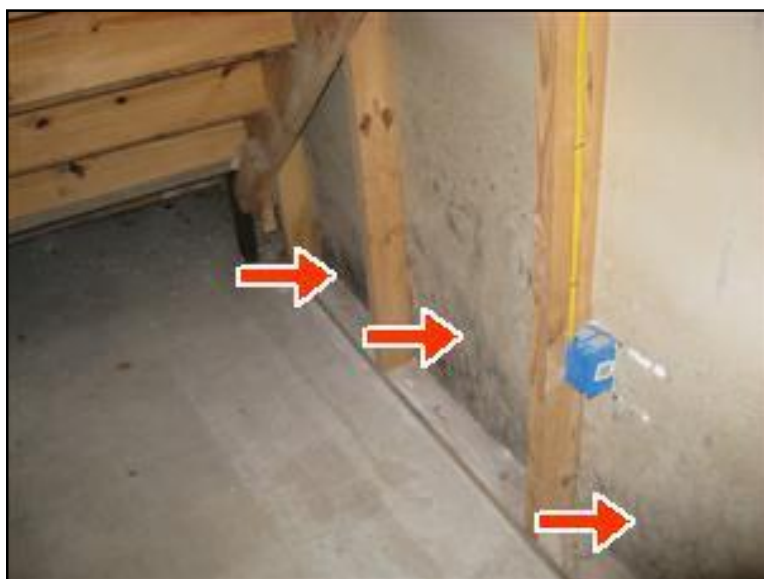
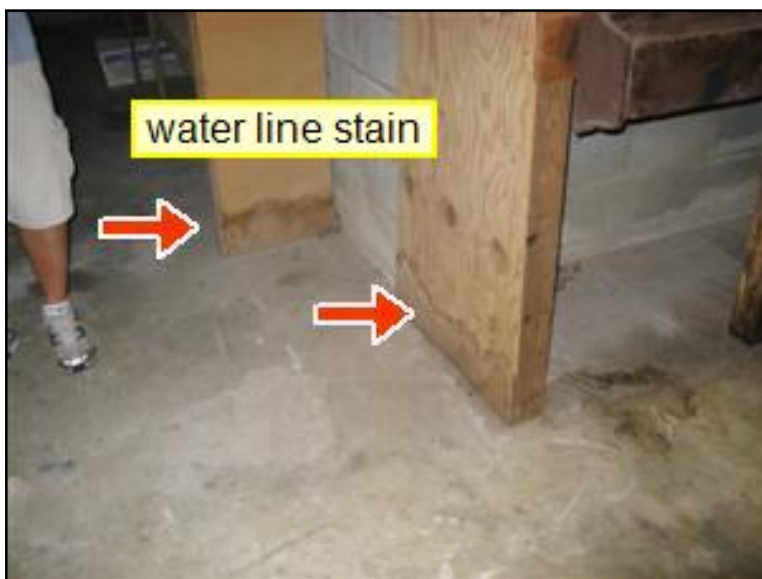
1.0 (1) White efflorescence (powder substance) on block wall indicates moisture is in contact with the masonry. This does not necessarily indicate that intrusion will occur. I recommend checking the gutters and the downspout drain lines for proper operation. Also, a water proofing paint could be applied to the interior side of the block if necessary. Efflorescence is found on many homes without water intrusion occurring inside the home. But, it should alert you to the possibility that future steps may be needed.

(2) Water signs on cedar wall and trim. Also a mold like substance on carpet at lower level and under stairs. I did not inspect or test for mold and I am unable to determine if water intrusion occurs.

(1) White efflorescence (powder substance) on block wall indicates moisture is in contact with the masonry. This does not necessarily indicate that intrusion will occur. I recommend checking the gutters and the downspout drain lines for proper operation. Also, a water proofing paint could be applied to the interior side of the block if necessary. Efflorescence is found on many homes without water intrusion occurring inside the home. But, it should alert you to the possibility that future steps may be needed.

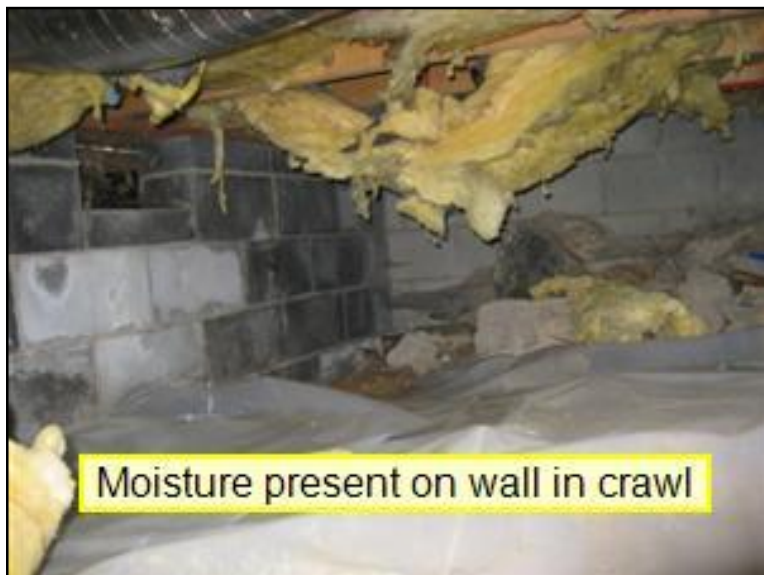
1.0 Picture 5 crawlspace under kitchen

🔍 (3) Visible signs of water intrusion in the crawlspace (along front of home) are present from dampness along the block wall. I am unable to determine the extent of intrusion or how often it occurs. Cross ventilation may help as the crawls has no ventilation. I recommend further investigation or correction by a qualified licensed contractor or water infiltration specialist. Refer to the diagram as a guide if a drainage system is needed.

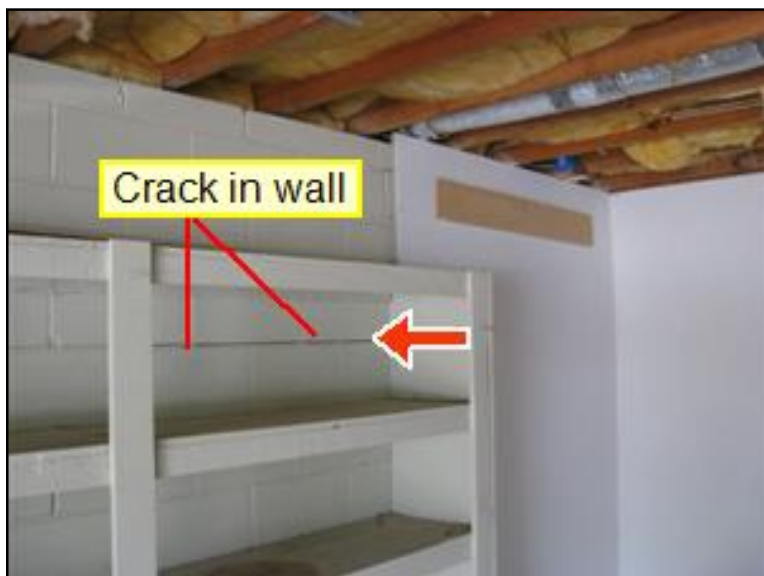
1.1 Picture 1

🔍 **1.1** There is a horizontal crack(s) in the foundation wall at the left side (facing front). These cracks do not appear significant to require repairs at this time. This is my opinion and you should seek a second opinion by a qualified person.

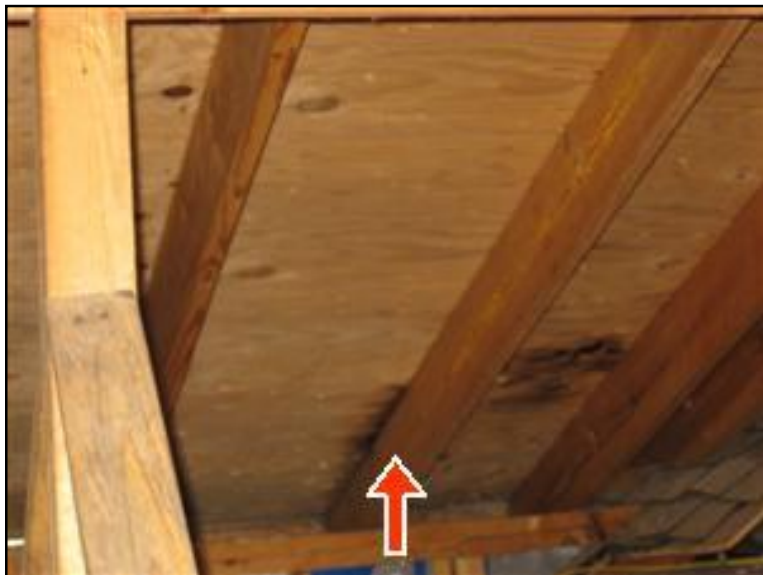
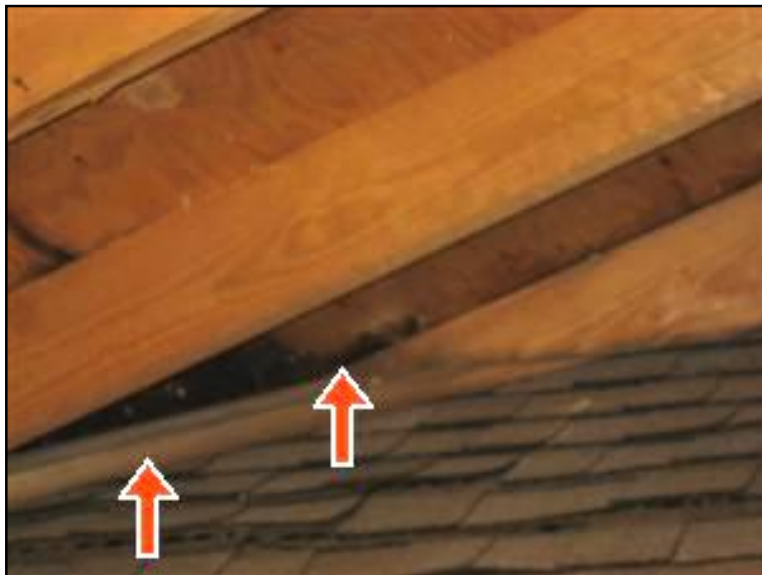
1.5 Picture 1

🔍 **1.5** Leak signs in attic perhaps or likely from the **old roof** as this newer roof appears in tact. I am unable to determine if leak exists due to no recent rain.

- Leak signs in attic perhaps or likely from the **old roof** as this newer roof appears in tact. I am unable to determine if leak exists due to no recent rain.

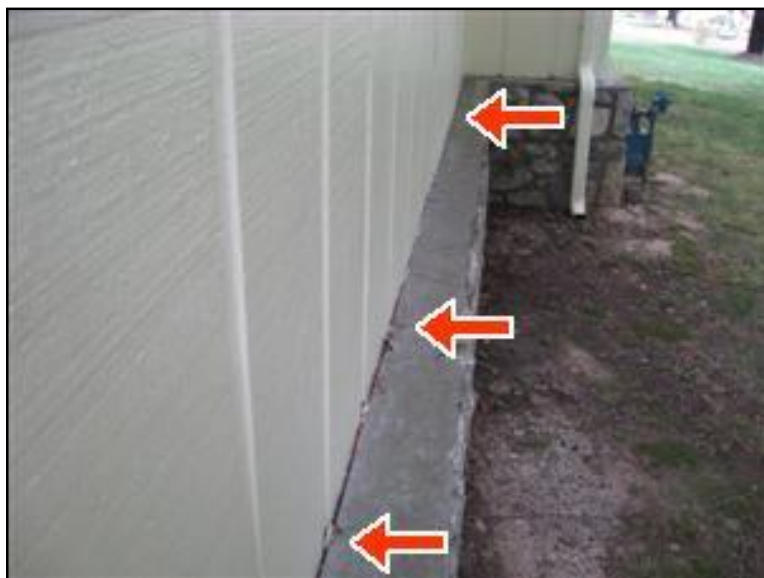
2.0 Picture 1

2.0 Periodical maintenance caulking needed and recommended to keep water from weeping under siding at concrete shelf. FYI

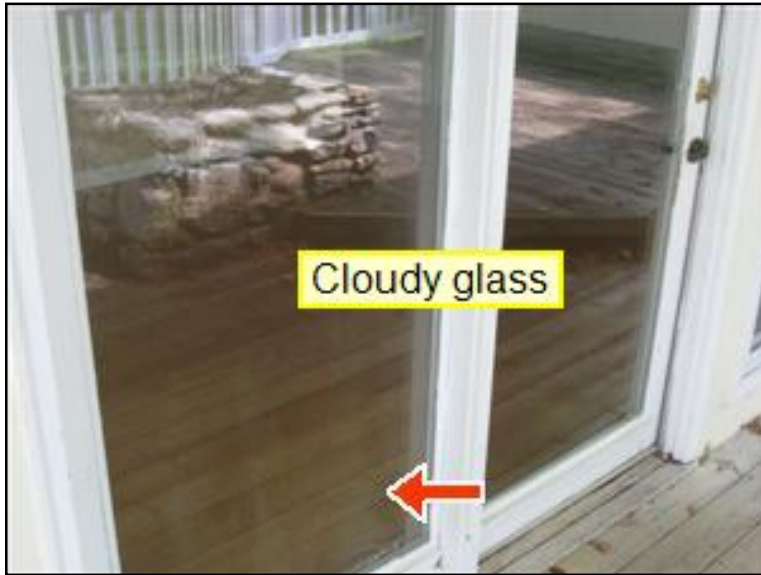
2.1 Picture 1

2.1 Patio doors at rear of home are cloudy or seal is broken. Glass panes that have lost their seal (cloudy) can usually be replaced without replacing the entire unit. A qualified contractor should inspect and repair as needed.

Patio doors at rear of home are cloudy or seal is broken. Glass panes that have lost their seal (cloudy) can usually be replaced without replacing the entire unit. A qualified contractor should inspect and repair as needed.

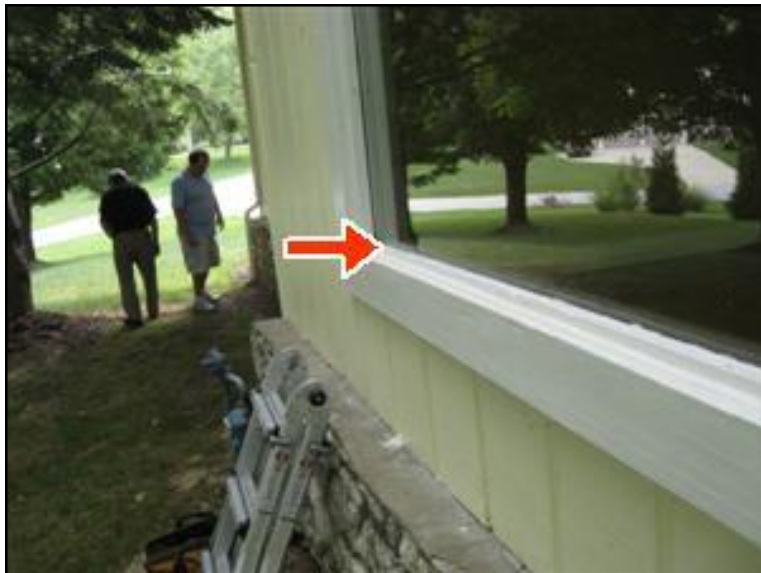
2.2 Picture 1

2.2 The trim stop for fixed pane is weathered and indicates that water may be getting below trim. I recommend a paintable sealant be applied and paint trim.

The trim stop for fixed pane is weathered and indicates that water may be getting below trim. I recommend a paintable sealant be applied and paint trim.

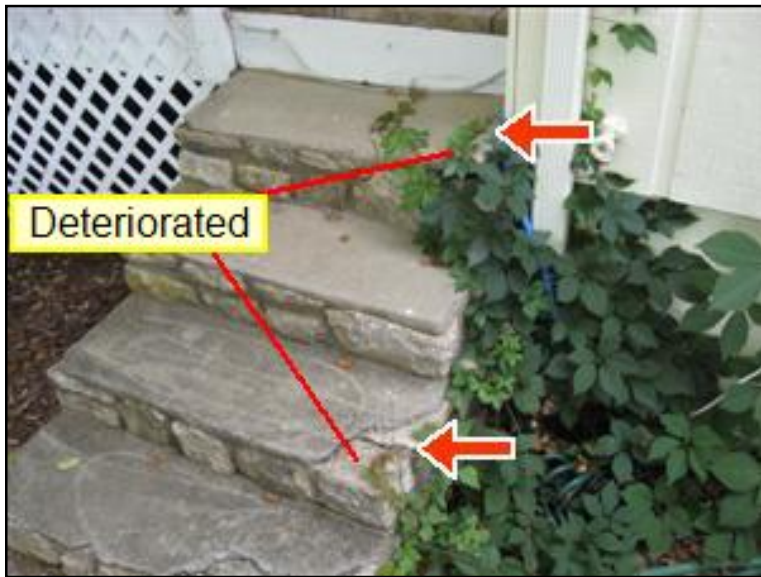
2.3 Picture 1

2.3 (1) The step tread on steps on the deck at the rear of home are deteriorated. A repair or replacement is needed. A skilled masonry contractor should perform the work.

A handrail may be needed

(1) The step tread on steps on the deck at the rear of home are deteriorated. A repair or replacement is needed. A skilled masonry contractor should perform the work.

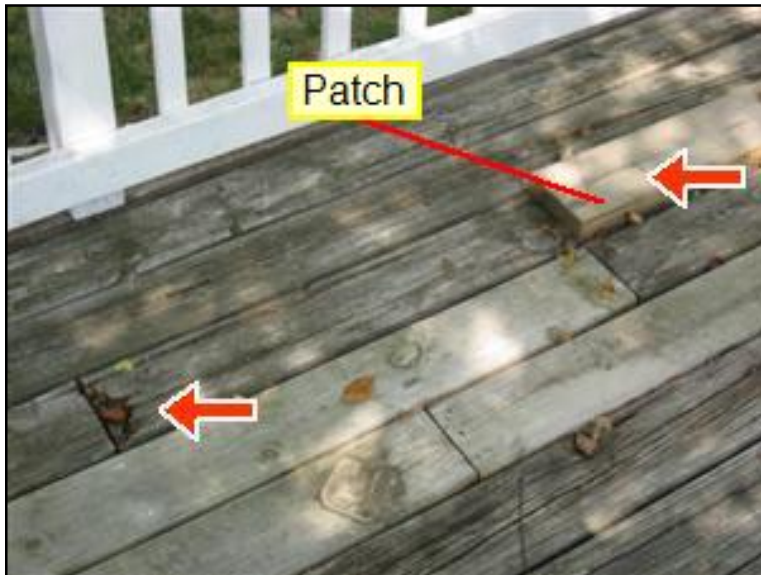
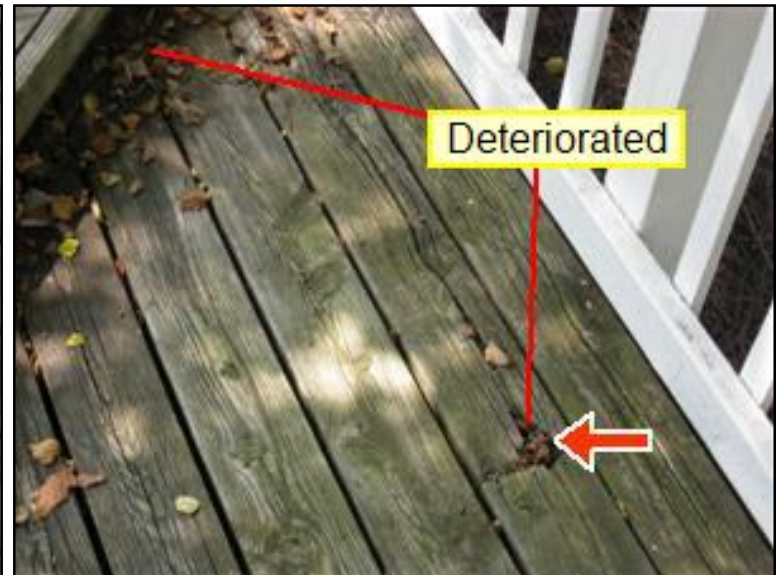
2.3 Picture 2

🔨 (2) The 2x6 decking on the deck at the rear of home has several boards that are deteriorated. A general replacement is likely. A qualified contractor should determine whether a repair or replacement is needed.

(2) The 2x6 decking on the deck at the rear of home has several boards that are deteriorated. A general replacement is likely. A qualified contractor should determine whether a repair or replacement is needed.

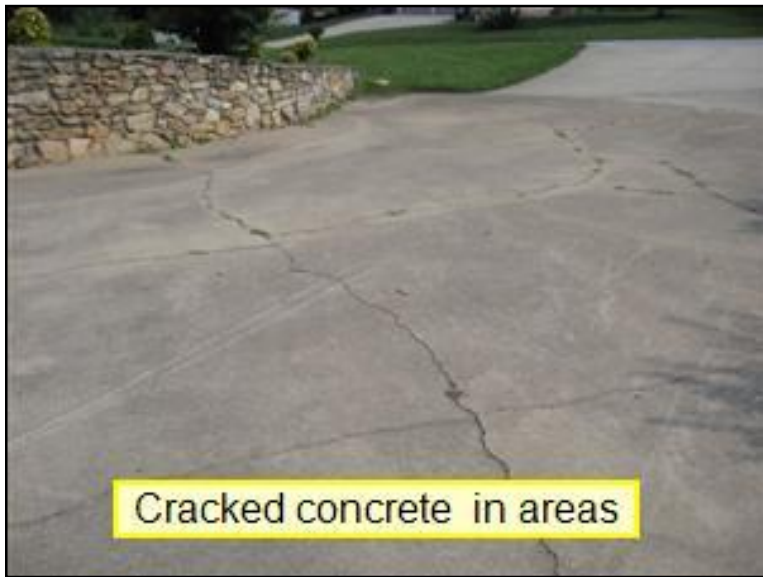
2.4 Picture 1

🔨 2.4 The concrete drive at the front of home is is pitted in areas and has settlement cracks. Further deterioration can occur if not repaired. A qualified contractor should inspect and repair as needed.

The concrete drive at the front of home is pitted in areas and has settlement cracks. Further deterioration can occur if not repaired. A qualified contractor should inspect and repair as needed.

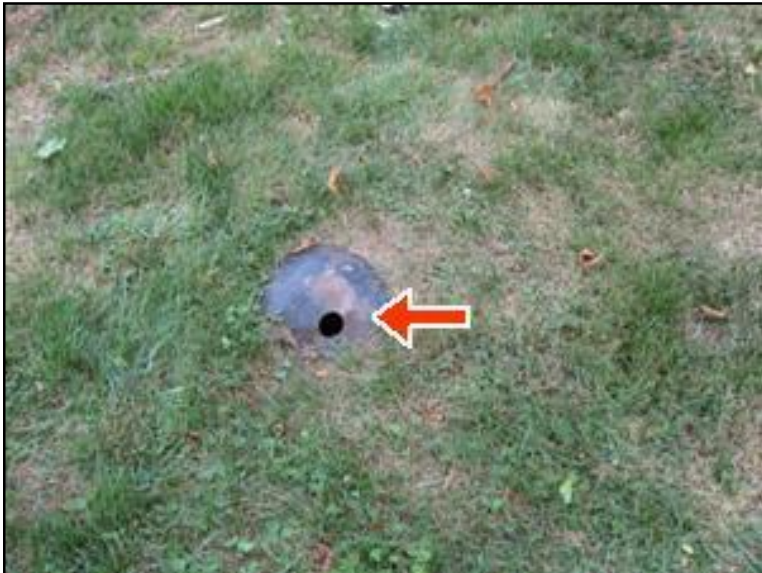
2.6 Picture 1

🔍 **2.6 (1)** Old propane tank in ground and is discontinued. I did not determine if gas remains in discontinued tank? I recommend further investigation by a qualified person.

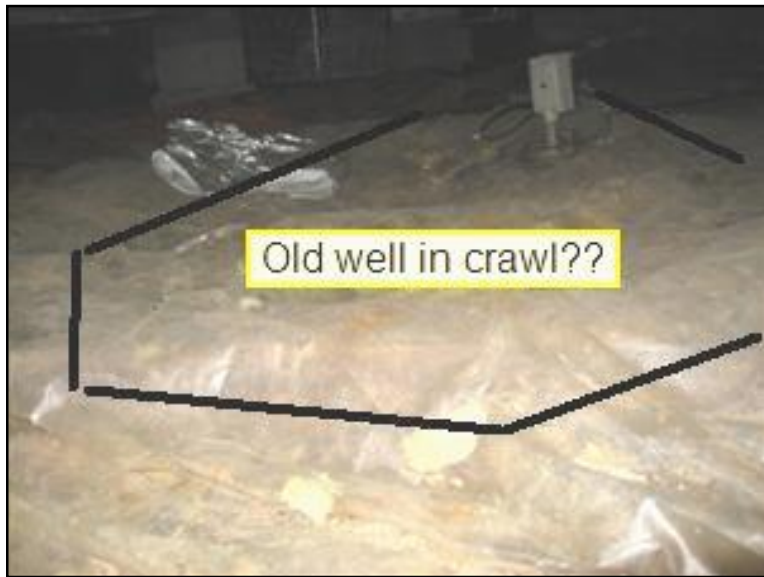
2.6 Picture 2 in crawlspace under new addition

🔍 **(2)** There is an odd configuration in ground under addition in crawlspace. This may be an old well? I am unable to determine. I recommend a qualified well drilling company or plumber investigate further to determine if any further action is needed to correct.

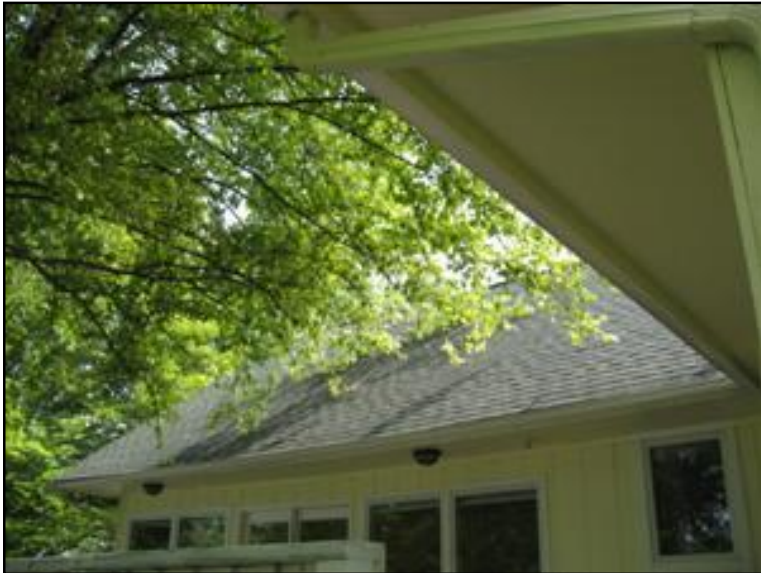
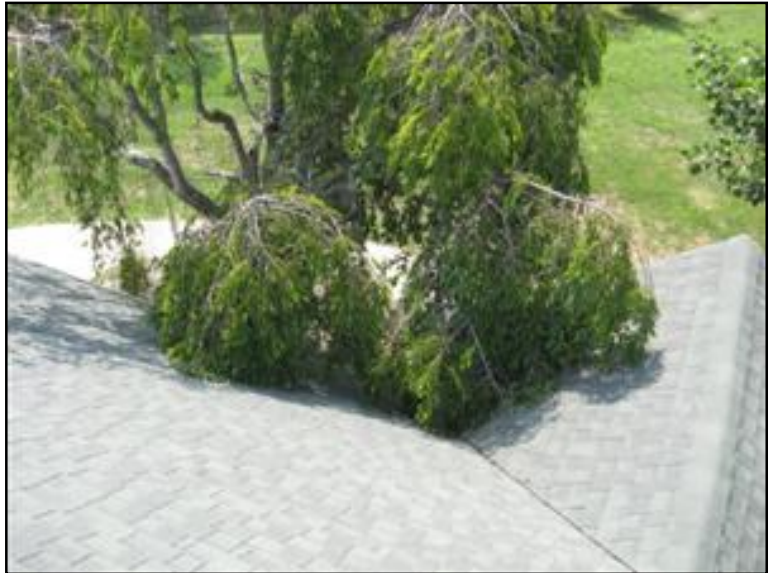
3.0 Picture 1 Rear of home

3.0 (1) The tree limbs that are in contact with roof or hanging near roof should be trimmed.

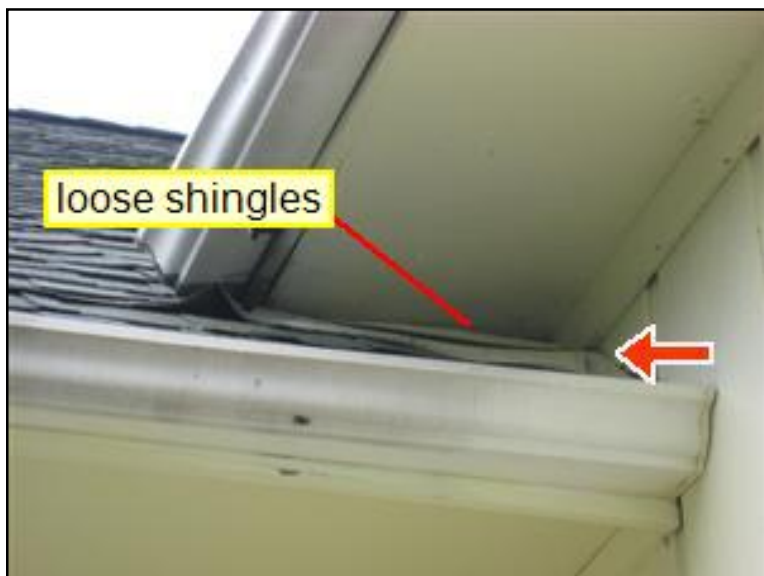
3.0 Picture 3

(2) Shingles loose under eave at front of home, needs adhesive.

(2) Shingles loose under eave at front of home, needs adhesive.

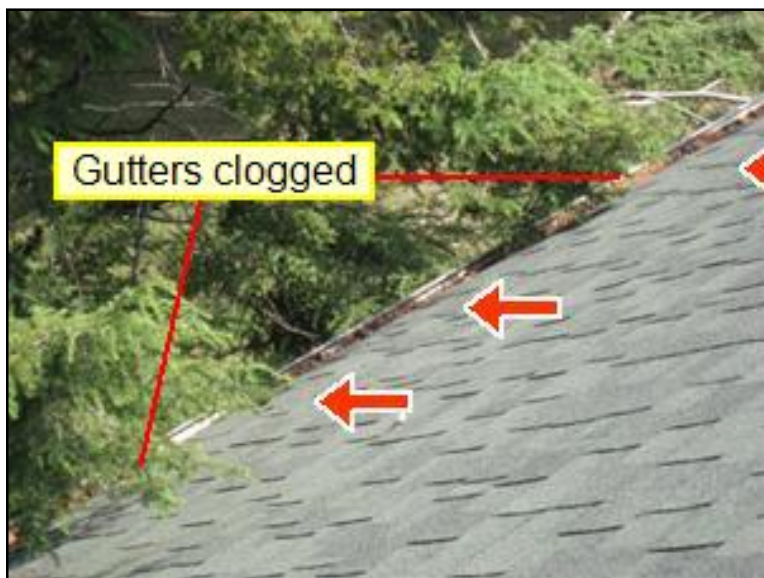
3.3 Picture 1

3.3 The gutter needs cleaning of debris at the virtually all areas where gutters are installed. Gutters that drain poorly or clogged can lead to many costly problems such as deterioration of fascia, soffit or roof edge. It can also cause gutters to pull loose and lead to possible water intrusion. A qualified person should repair or replace as needed.

The gutter needs cleaning of debris at the virtually all areas where gutters are installed. Gutters that drain poorly or clogged can lead to many costly problems such as deterioration of fascia, soffit or roof edge. It can also cause gutters to pull loose and lead to possible water intrusion. A qualified person should repair or replace as needed.

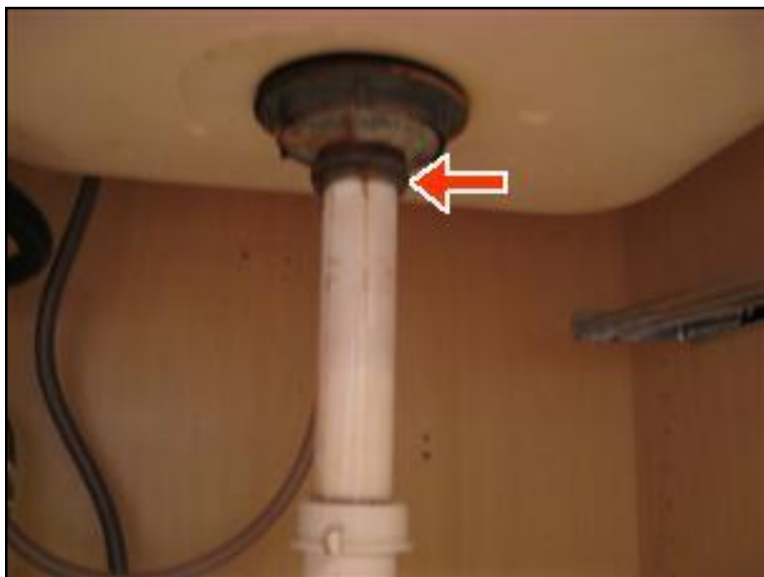
4.0 Picture 1 Right sink basin

4.0 (1) The basket strainer had leaked and corrected itself for the time being at the Kitchen sink. Repairs are needed. A qualified person should repair as necessary.

(1) The basket strainer had leaked and corrected itself for the time being at the Kitchen sink. Repairs are needed. A qualified person should repair as necessary.

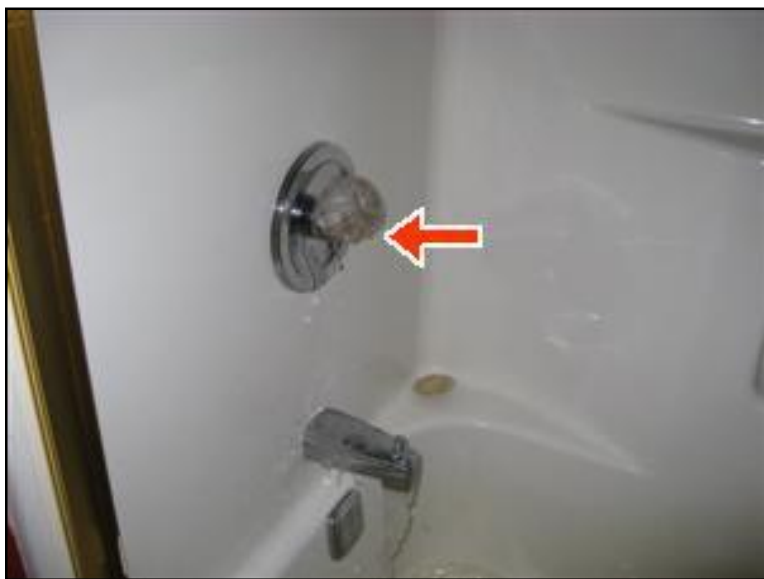
4.1 Picture 1 hall bath

🔧 4.1 (1) The control knob leaks at the hall bath. Repairs are needed. A qualified licensed plumber should repair or correct as needed.

(1) The control knob leaks at the hall bath. Repairs are needed. A qualified licensed plumber should repair or correct as needed.
-

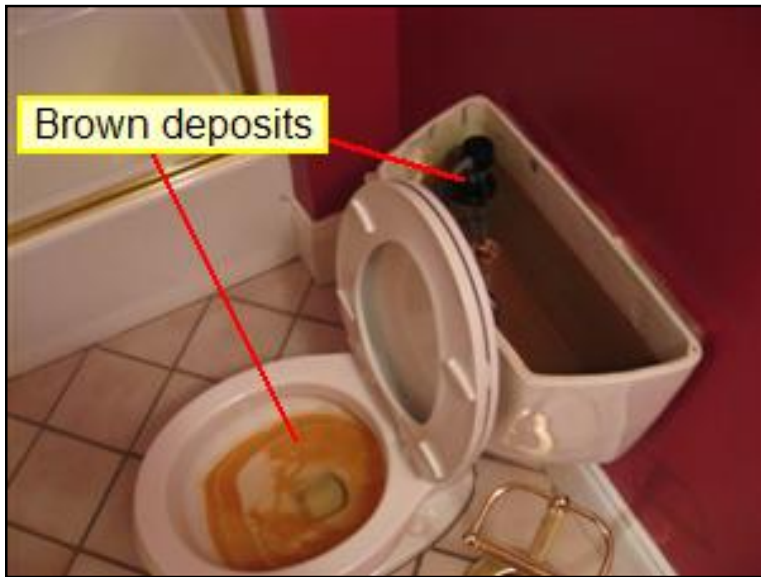
4.1 Picture 2

🔍 (2) Brown deposits are on the plumbing fixtures which indicates a filter may be needed. Filter in place and appears dirty but I am unable to determine if you need a different or additional filter. I did not test water for bacteria or other. I recommend contacting a water filtration company.

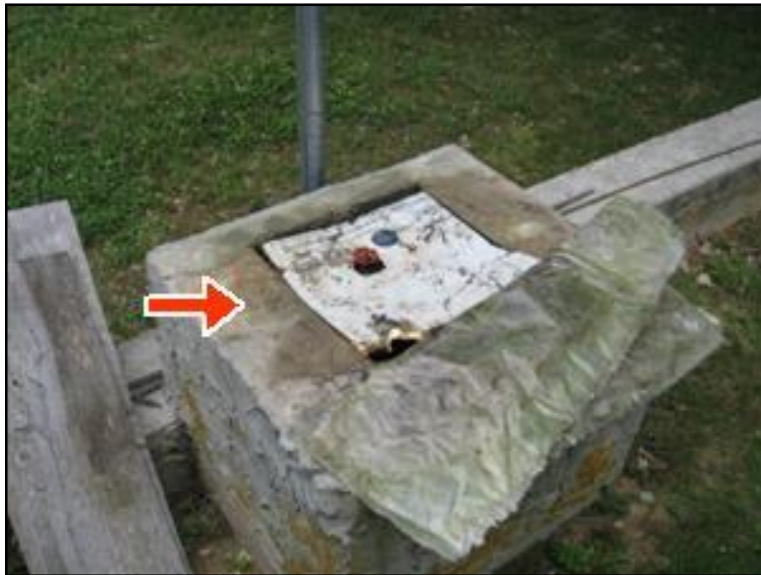
4.1 Picture 3 Well head

🔧 (3) I recommend the well head lid be insulated better before winter. FYI

(3) I recommend the well head lid be insulated better before winter. FYI

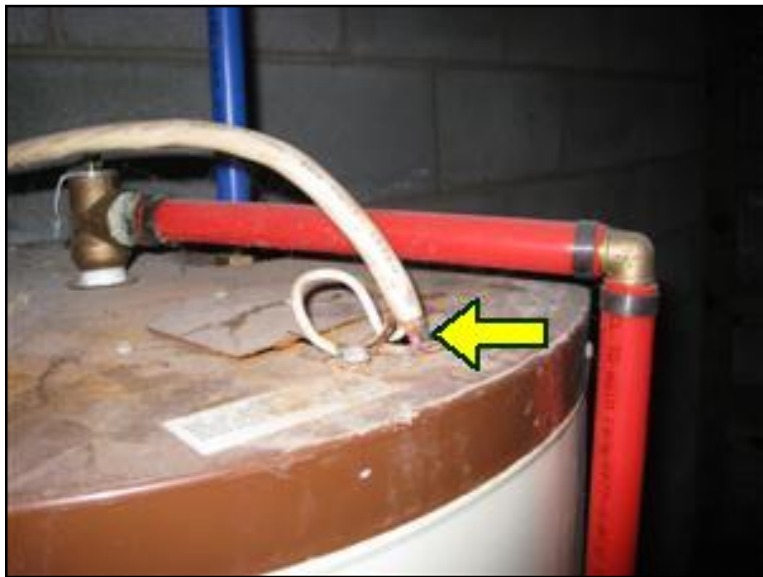
4.2 Picture 1

🔧 **4.2** The wiring for the water heater missing romex connector. Electrical issues are considered a hazard until repaired. I recommend a licensed electrician correct as necessary.

The wiring for the water heater missing romex connector. Electrical issues are considered a hazard until repaired. I recommend a licensed electrician correct as necessary.

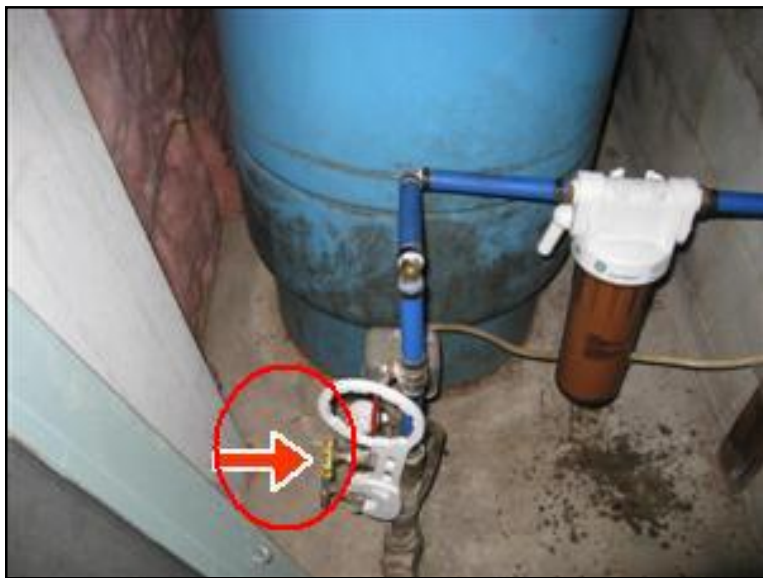
4.3 Picture 1 In basement

4.3 The main shut off is the yellow knob located in the basement at the pressure tank. This is for your information.

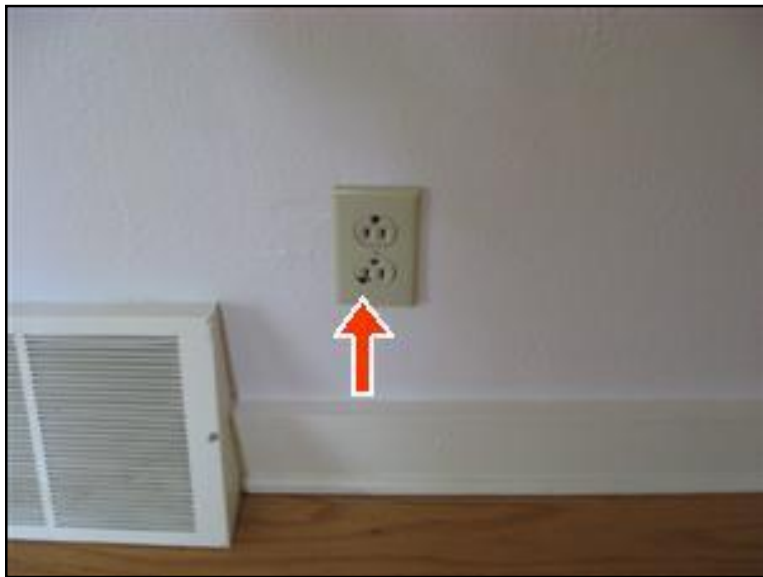
5.3 Picture 1

5.3 (1) The wall switch is broken (unsafe) at the upstairs closet for air handler. At least two outlets are broken at LR and entry way. Electrical issues are considered a hazard until repaired. A qualified licensed electrician should perform repairs that involve wiring.

(1) The wall switch is broken (unsafe) at the upstairs closet for air handler. At least two outlets are broken at LR and entry way. Electrical issues are considered a hazard until repaired. A qualified licensed electrician should perform repairs that involve wiring.

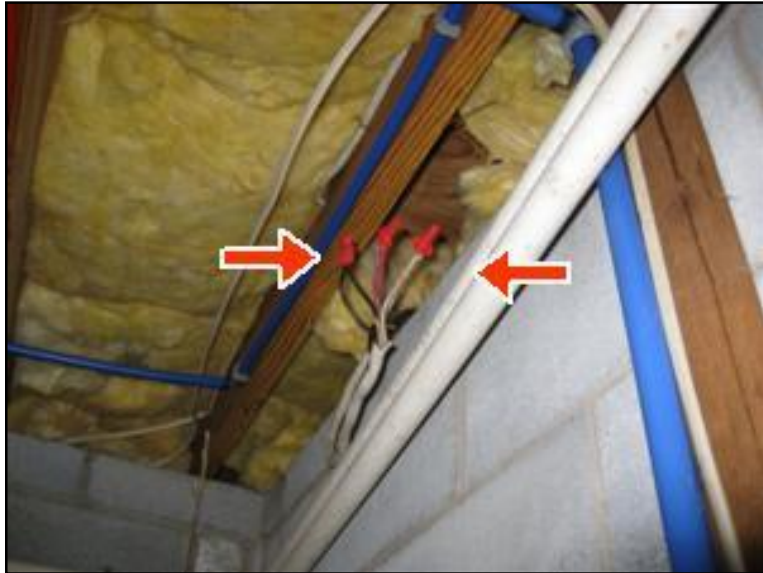
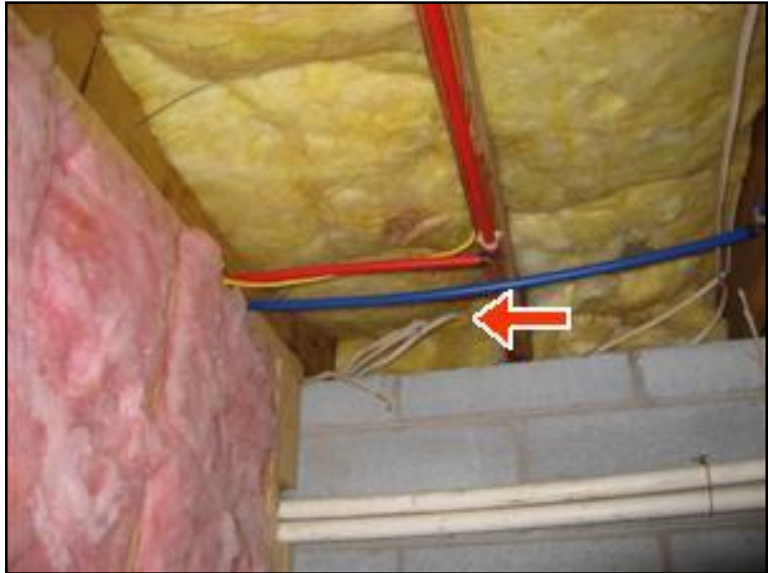
5.3 Picture 2

🔧 (2) Several loose wire ends needs placing inside a box with a cover-plate in the basement at the pressure tank of well. I recommend repair as needed.

(2) Several loose wire ends needs placing inside a box with a cover-plate in the basement at the pressure tank of well. I recommend repair as needed.

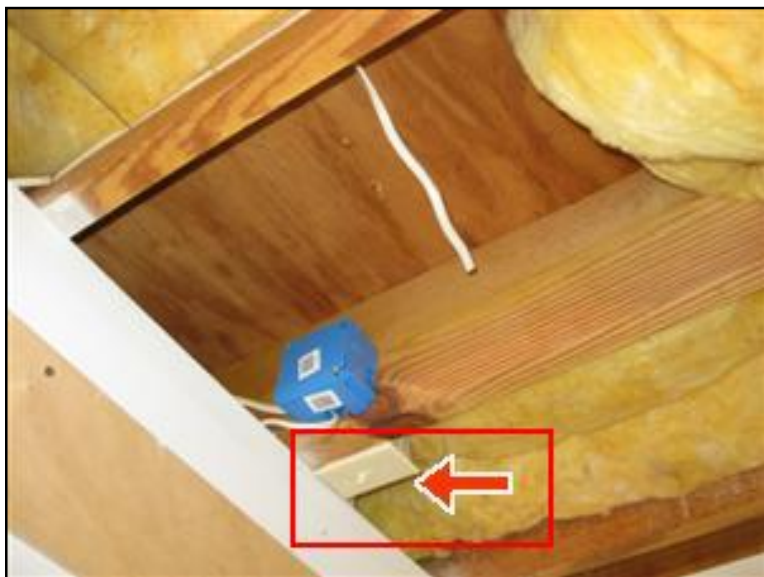
5.3 Picture 4

🔍 (3) Wall switch on ceiling in Garage, purpose unknown

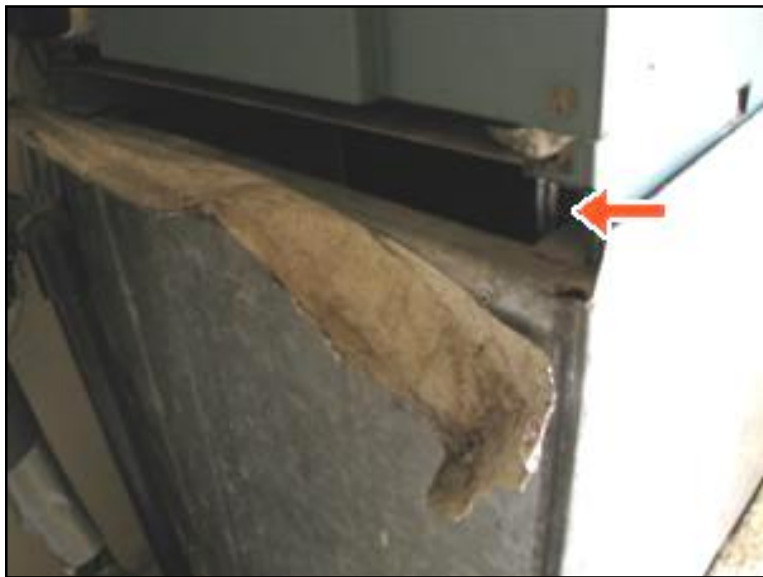
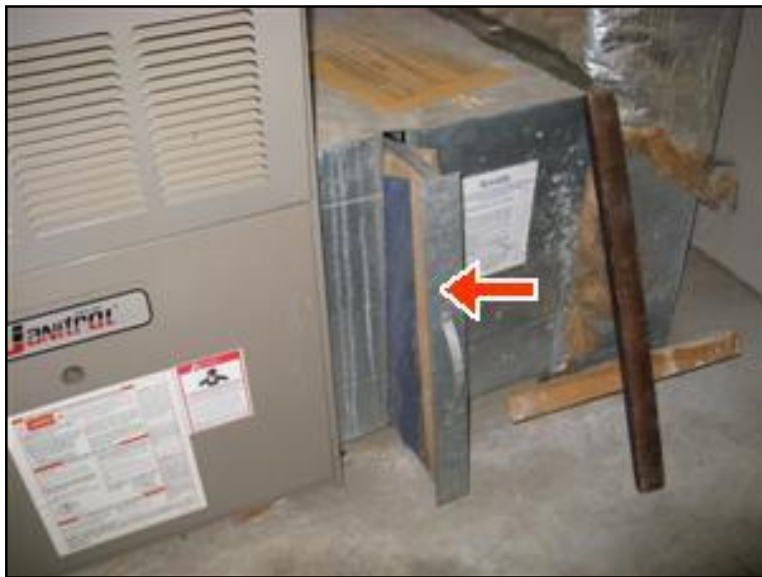
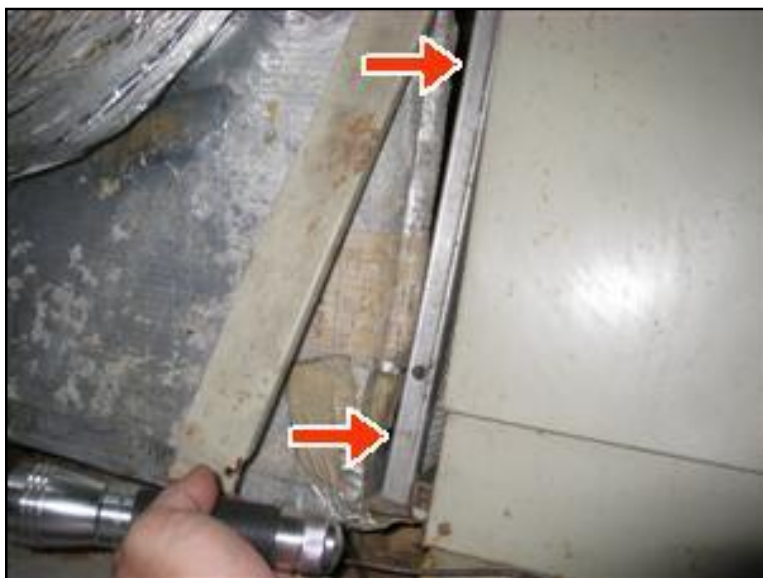
6.3 Picture 1

**6.3** (1) The washable filter is collapsed and needs replacing at upstairs. The filter needs replacing with a rigid frame to prevent filter from falling out of alignment. (Picture 1) The filter in basement (Picture 2) needs replacement and in crawlspace which is difficult to access due to the crawlspace (Picture 3). A qualified person should repair or replace as needed

frame to prevent filter from falling out of alignment. (Picture 1) The filter in basement (Picture 2) needs replacement and in crawlspace which is difficult to access due to the crawlspace (Picture 3). A qualified person should repair or replace as needed

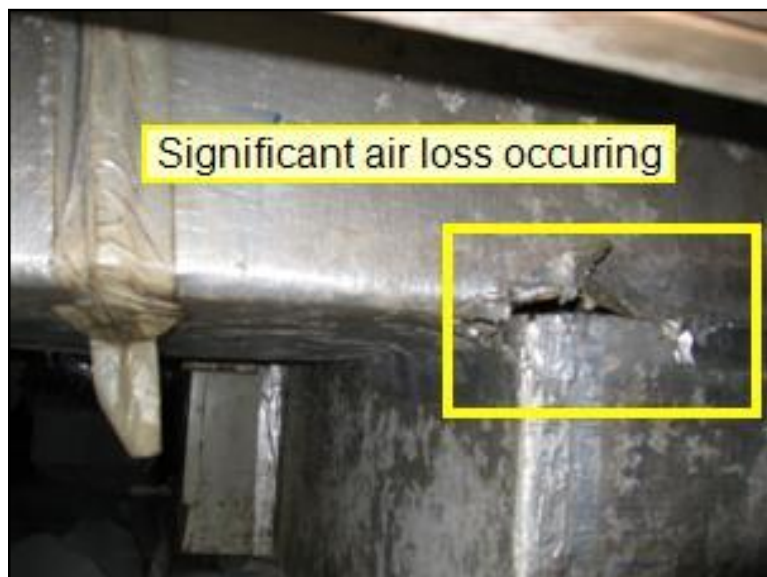
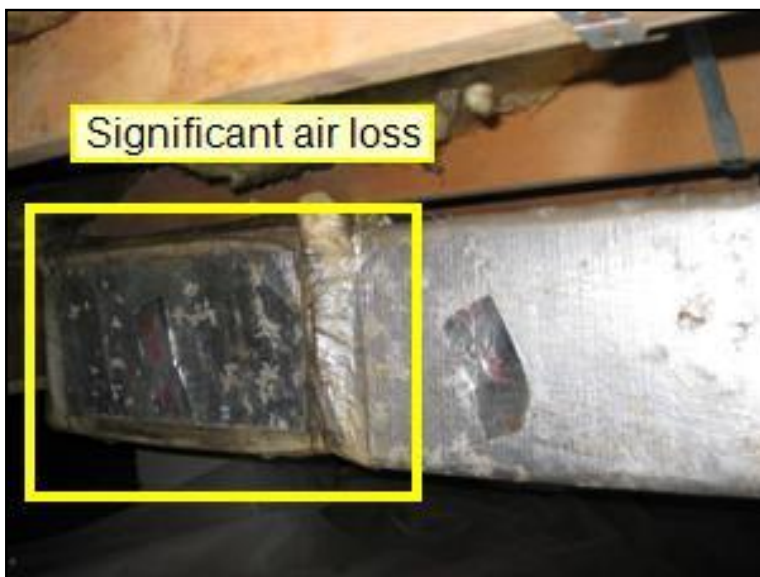
6.3 Picture 4 crawlspace new addition

🔧 (2) The supply duct pipe or main plenum is failing in the crawlspace. Energy loss is occurring in crawlspace and immediate correction is needed. A licensed HVAC contractor should service or repair unit.

(2) The supply duct pipe or main plenum is failing in the crawlspace. Energy loss is occurring in crawlspace and immediate correction is needed. A licensed HVAC contractor should service or repair unit.

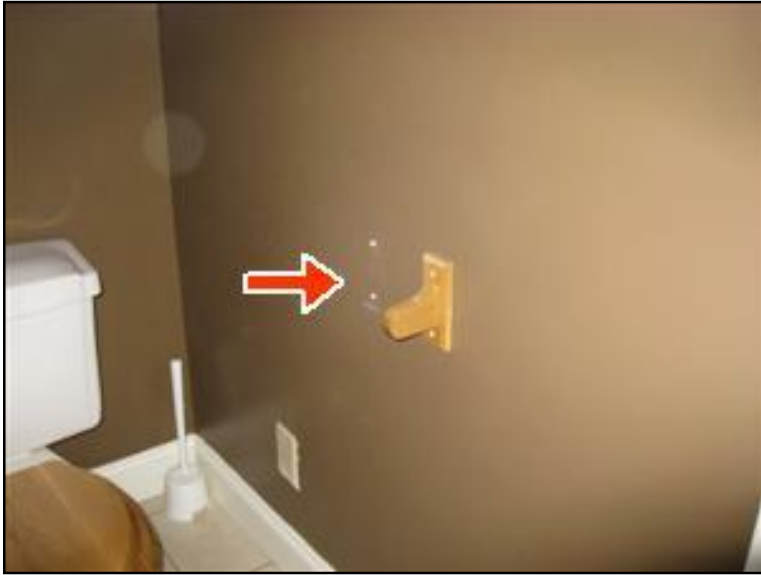
8.1 Picture 1

**8.1** The tissue holder on the wall is damaged at the master bath. I recommend repair as necessary.

The tissue holder on the wall is damaged at the master bath. I recommend repair as necessary.

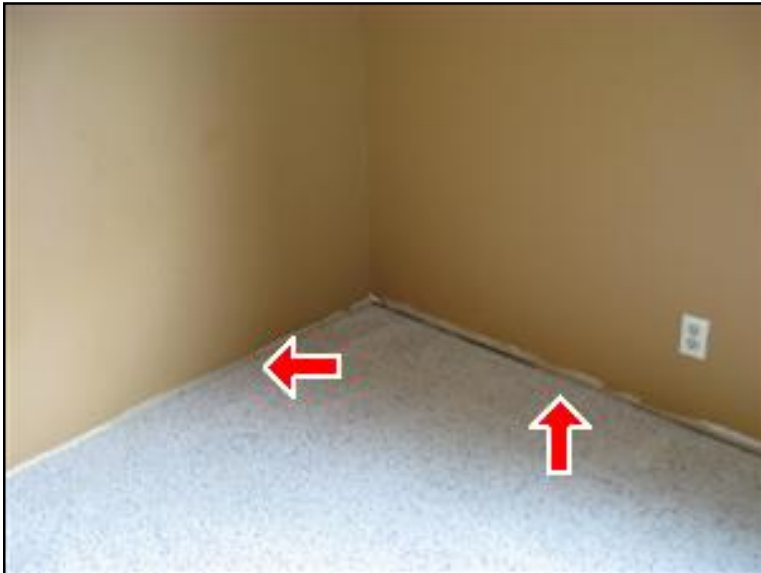
8.2 Picture 1

**8.2 (1)** The Baseboard is missing at the upstairs (right of hall bath). Repairs are needed. A qualified contractor should inspect and repair as needed.

(1) The Baseboard is missing at the upstairs (right of hall bath). Repairs are needed. A qualified contractor should inspect and repair as needed.
-

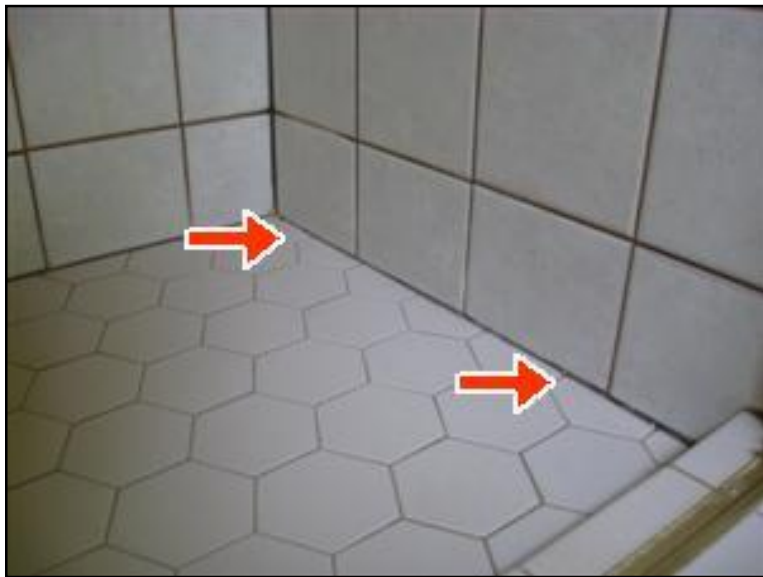
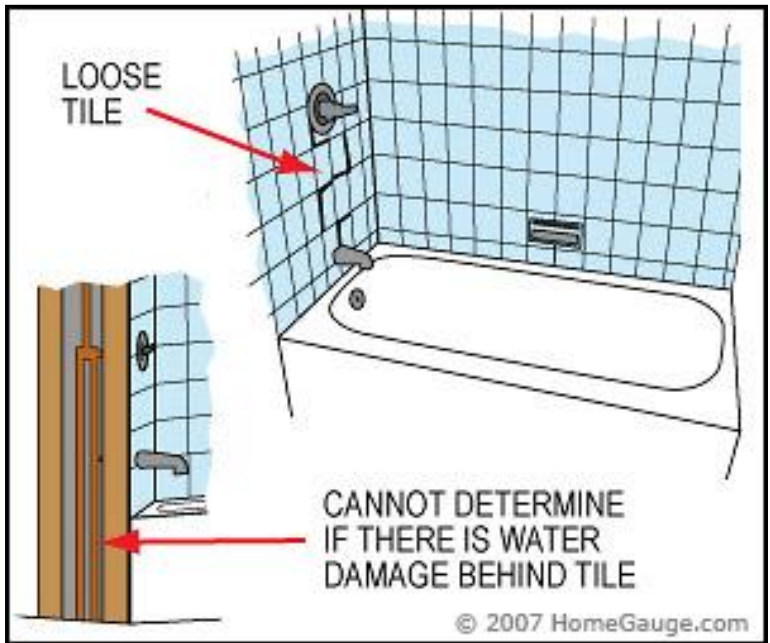
8.2 Picture 2 Upstairs bath

**(2)** Tile at shower pan and wall surround are loose and missing mortar or grout and sealer at the upstairs bath. Repairs are needed to prevent water damage to shower/bath. A qualified person should repair or replace as needed.

(2) Tile at shower pan and wall surround are loose and missing mortar or grout and sealer at the upstairs bath. Repairs are needed to prevent water damage to shower/bath. A qualified person should repair or replace as needed.

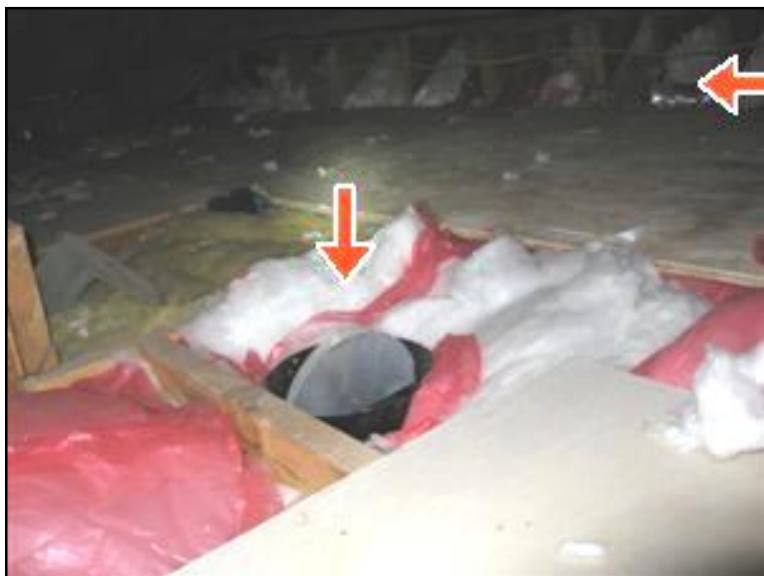
9.4 Picture 1

9.4 The Exhaust fan does not vent to outside at the hall bath and master bath. Vent pipes should terminate outside and not in the attic. Many homes have their vent pipe poised at the roof vent such as yours. It is up to you to determine whether or not this is a concern or needs further consideration from a general contractor. A qualified contractor should inspect and repair as needed.

outside and not in the attic. Many homes have their vent pipe poised at the roof vent such as yours. It is up to you to determine whether or not this is a concern or needs further consideration from a general contractor. A qualified contractor should inspect and repair as needed.

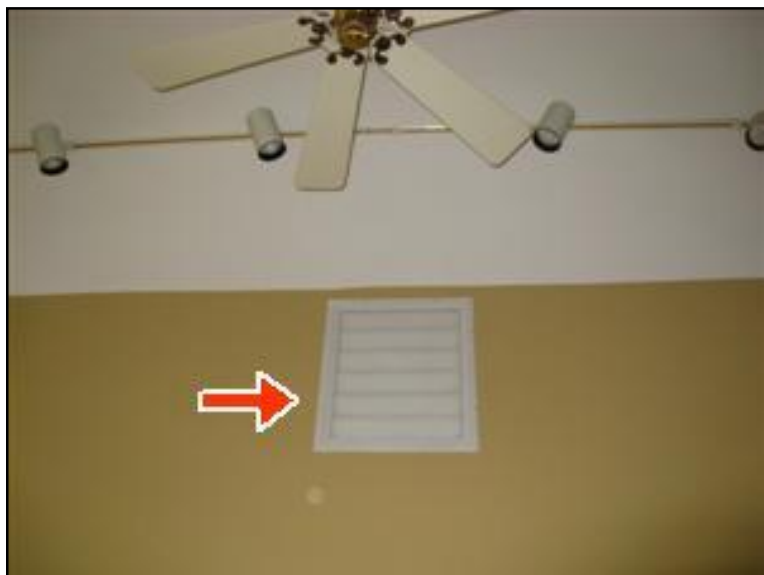
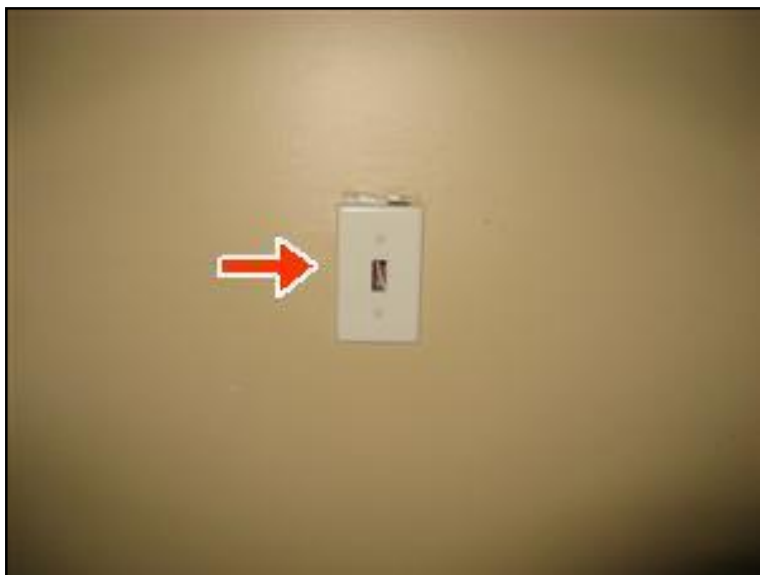
9.5 Picture 1

🔧 **9.5** Wall switch for room fan in wall has been removed. It is inoperable.
